Manhole Inspection Summary

Manhole # S35UU1008MH

Location Address: **318 WOODBOURNE AVE**

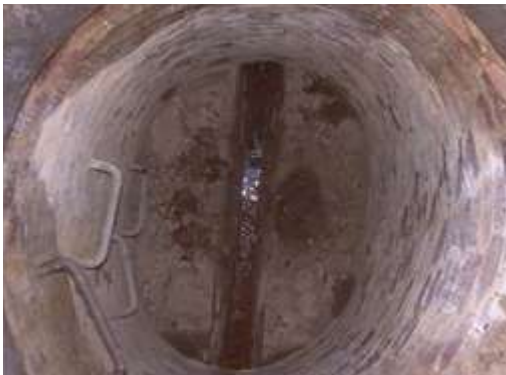
Top View

Bench debris.

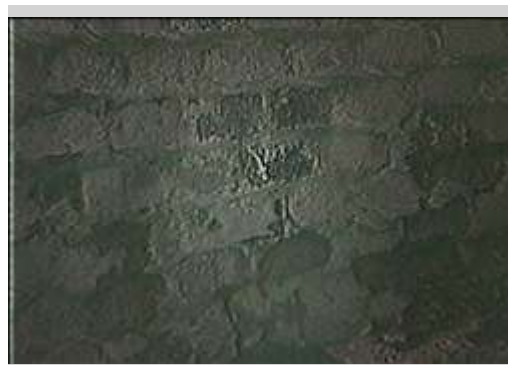
Defect

Barrel deterioration and infiltration.

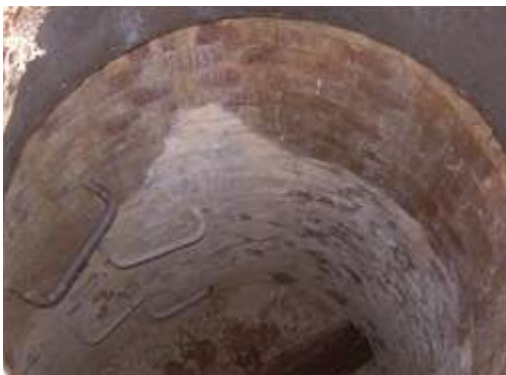
Defect

Frame leaks. Adjustment, Corbel and Barrel infiltration.

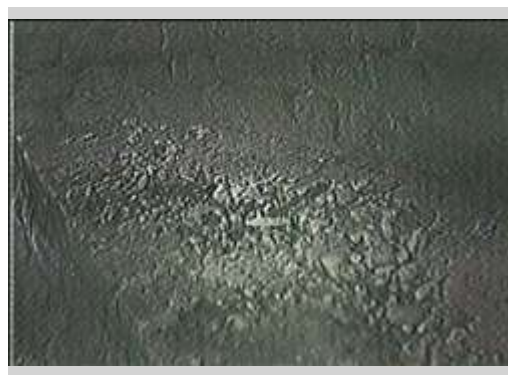
Defect

Barrel deterioration and infiltration.

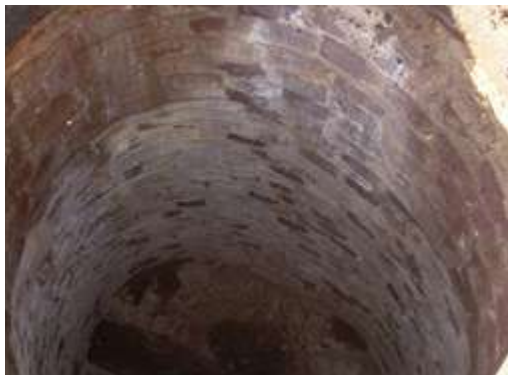
Defect

Frame leaks. Adjustment, Corbel and Barrel infiltration - other side.

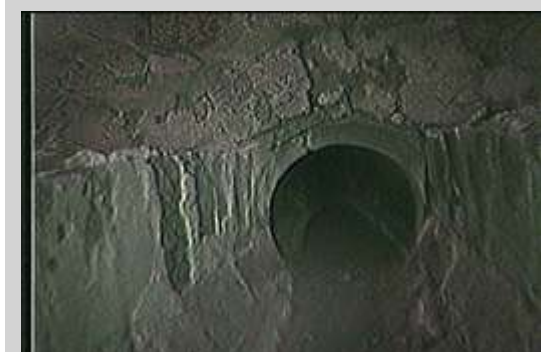
Pipe Out @ 12 O'Clock

Deposits: ☐ None ☒ **Mud** ☐ Sludge ☒ **Debris** ☐ Grease

Infiltration: **Evidence** Pipe Seal Cond: **Cracked**

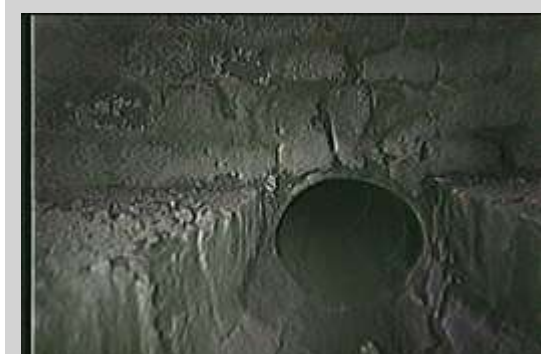
Pipe In @ 6 O'Clock

Deposits: ☐ None ☒ **Mud** ☐ Sludge ☒ **Debris** ☐ Grease

Infiltration: **Evidence** Pipe Seal Cond: **Cracked**
